SUBJECT: SHERATON INN • S. SAN FRANCISCO

SHERATON INN

SOUTH SAN FRANCISCO, CALIFORNIA

MBR JOB #98122

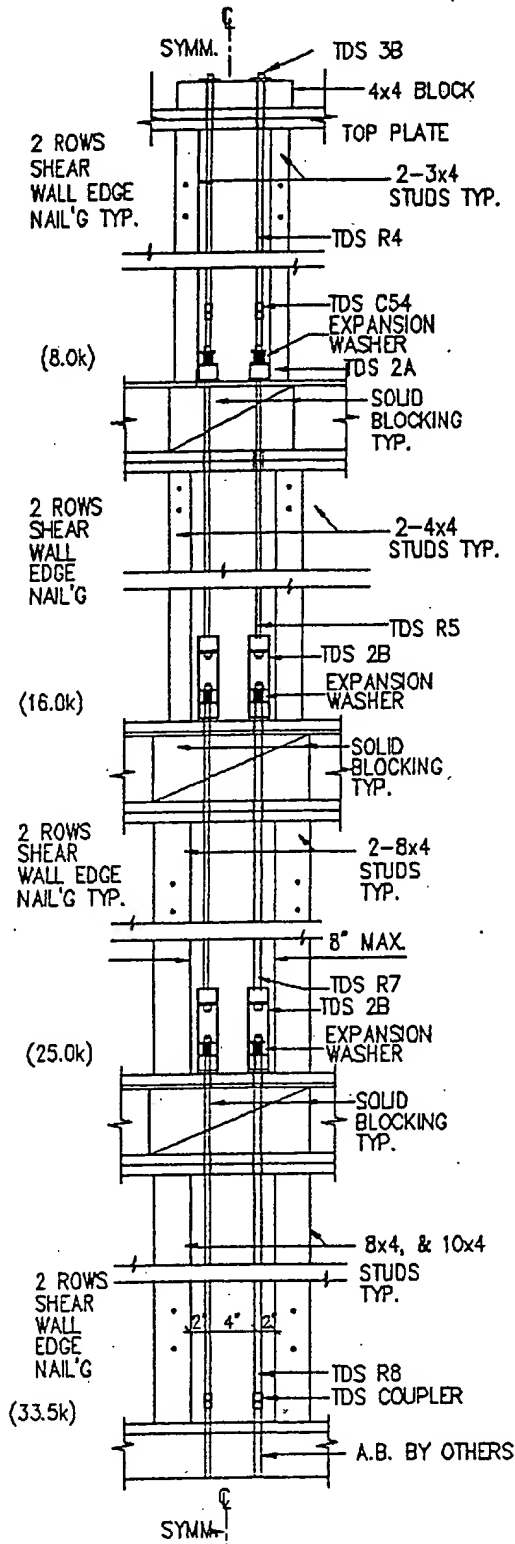
Level 4 (RODS) 10'
 Level 3 (RODS) 163'
 Level 2 (L) 30460 #
 Level 1 (STUDS) 36090 #

3B 2A 2B 2B (4578) 3B 2A 2B 2B (4578)

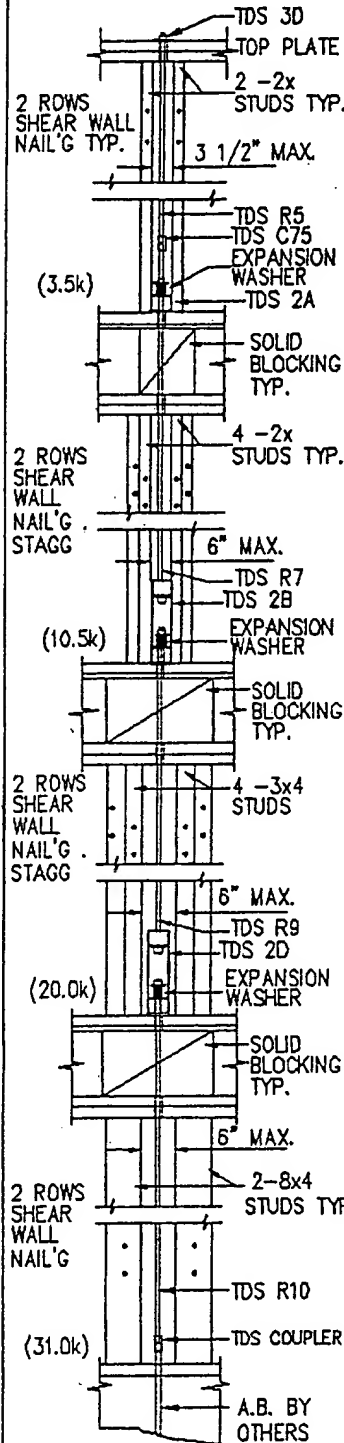
Level 4 (R) 8'
 Level 3 (L) #
 Level 2 (L) 23450 #
 Level 1 (ST) 31710 #

A.B.'S PER STRUCTURAL DWGS.

3D 2A 2D 2D (5,7,9,10)

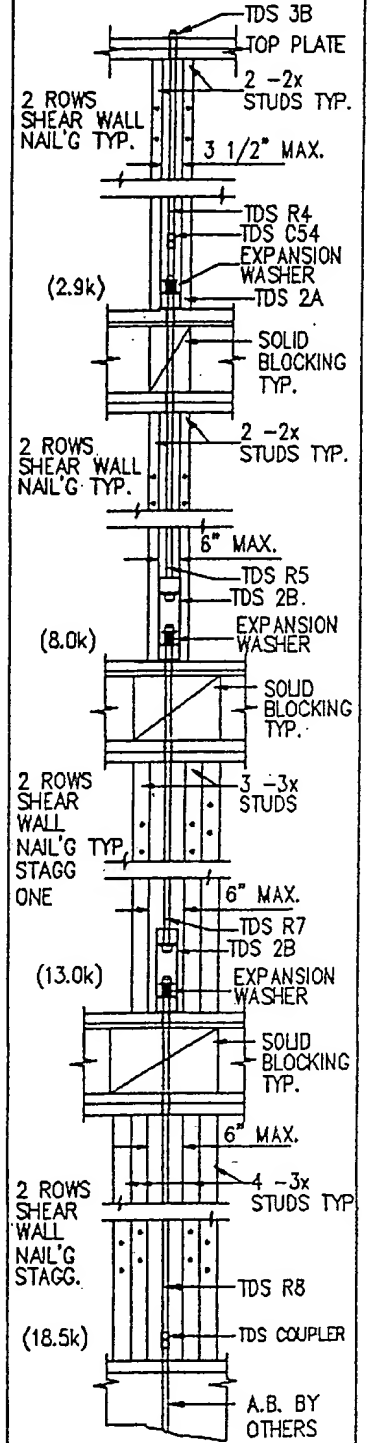
Level 4 (R) 5230 #
 Level 3 (R) 8180 #
 Level 2 (L) 15230 #
 Level 1 (R) 20940 #

A.B.'S PER STRUCTURAL DWGS.

3B 2A 2B 2B (4578)
